**ATK Launch Systems
Crane Safety & Handling Symposium**

Orbiter Payload Bay Bucket Hoist Mishap... An Accident We Should Never Forget

Bradford P. Lytle, P.E.

- KSC Orbiter Processing Facility, Orbiter Payload Bay Bucket Hoist Mishap
 - March 8, 1985, during final closeout of the orbiter Discovery, a payload bay access platform fell from its stowed position.
 - This resulted in damage to the Discovery's insulating blankets and forward payload bay door.
 - A Lockheed Technician suffered a broken leg.
 - This delayed launch by approximately three weeks.

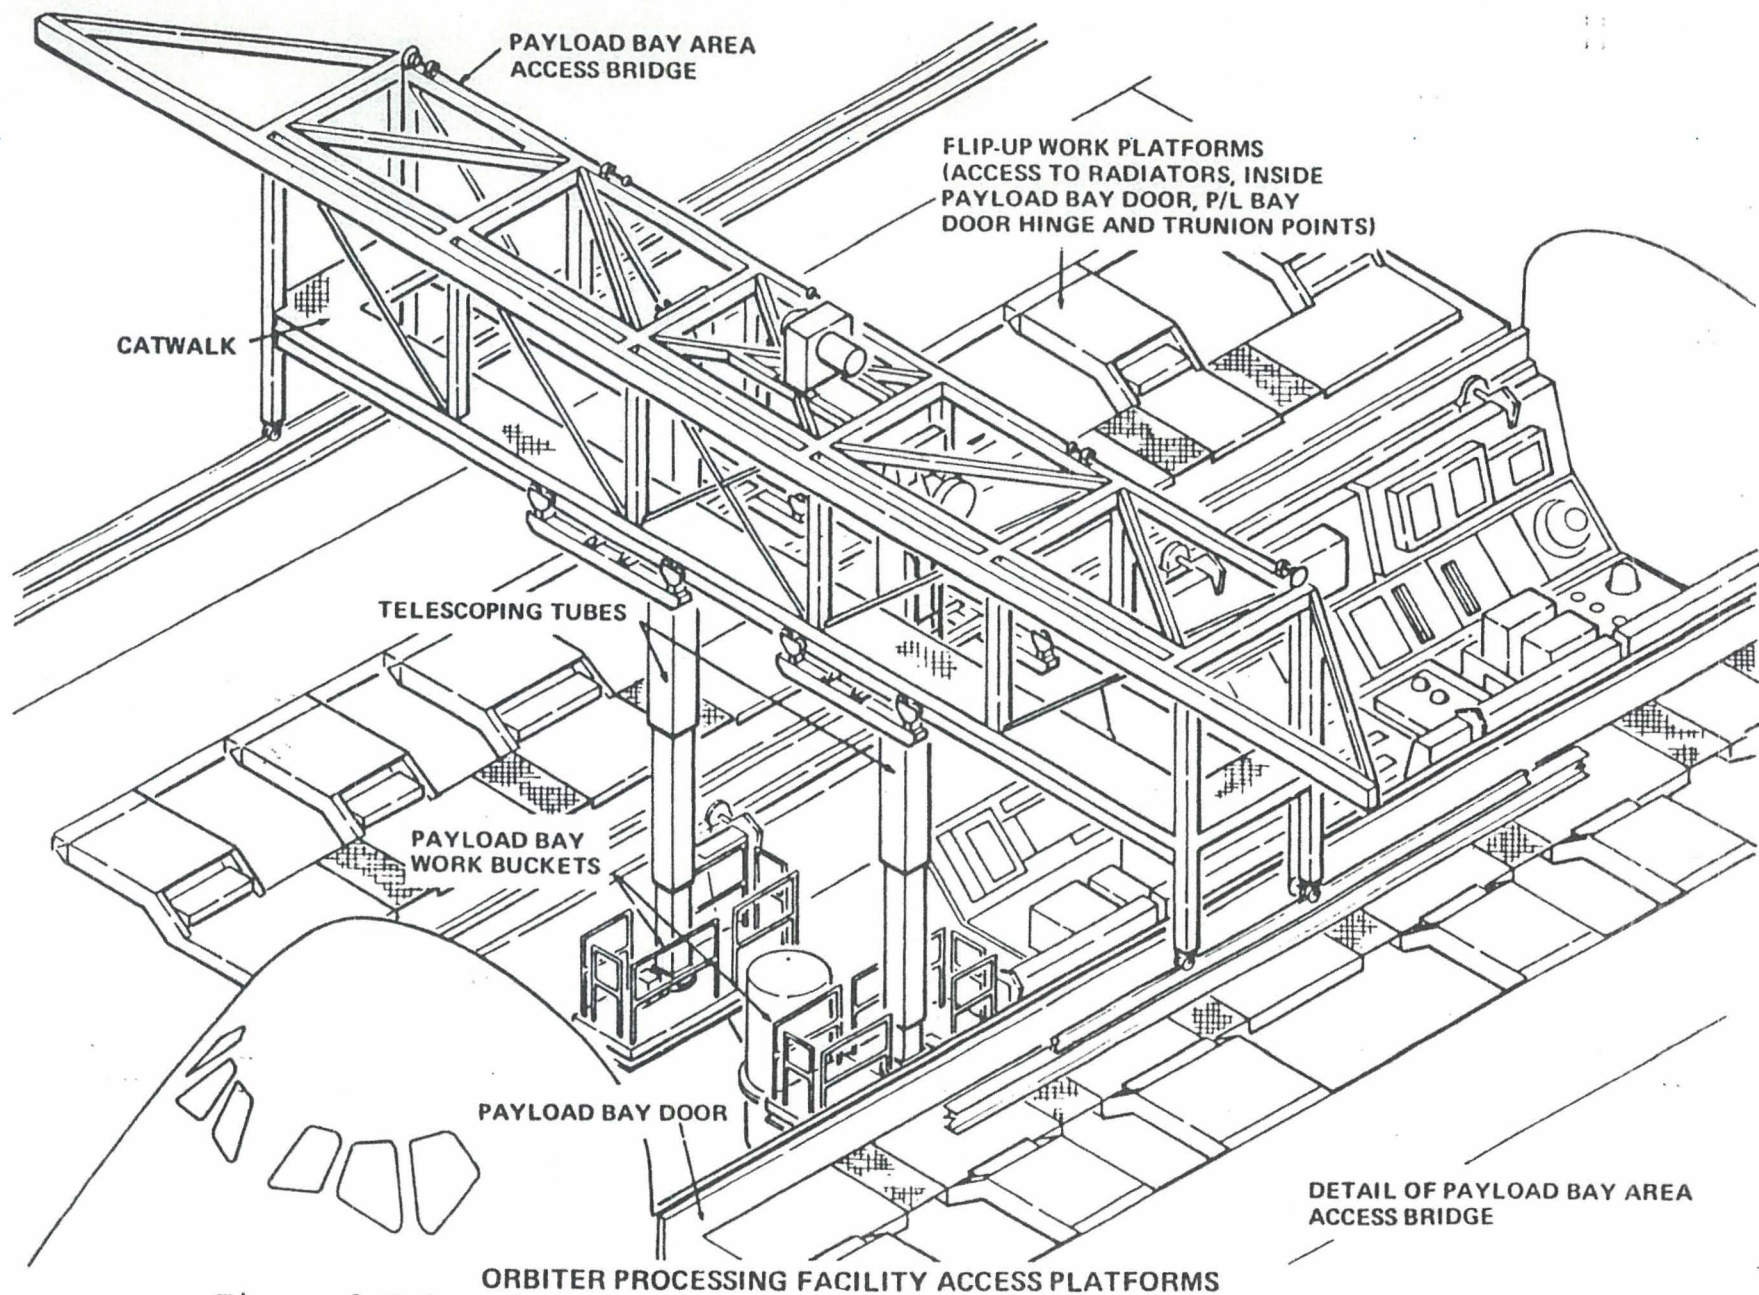
Figure 9-B-1. Sketch of OPF Access Platforms on bridge crane, upper view

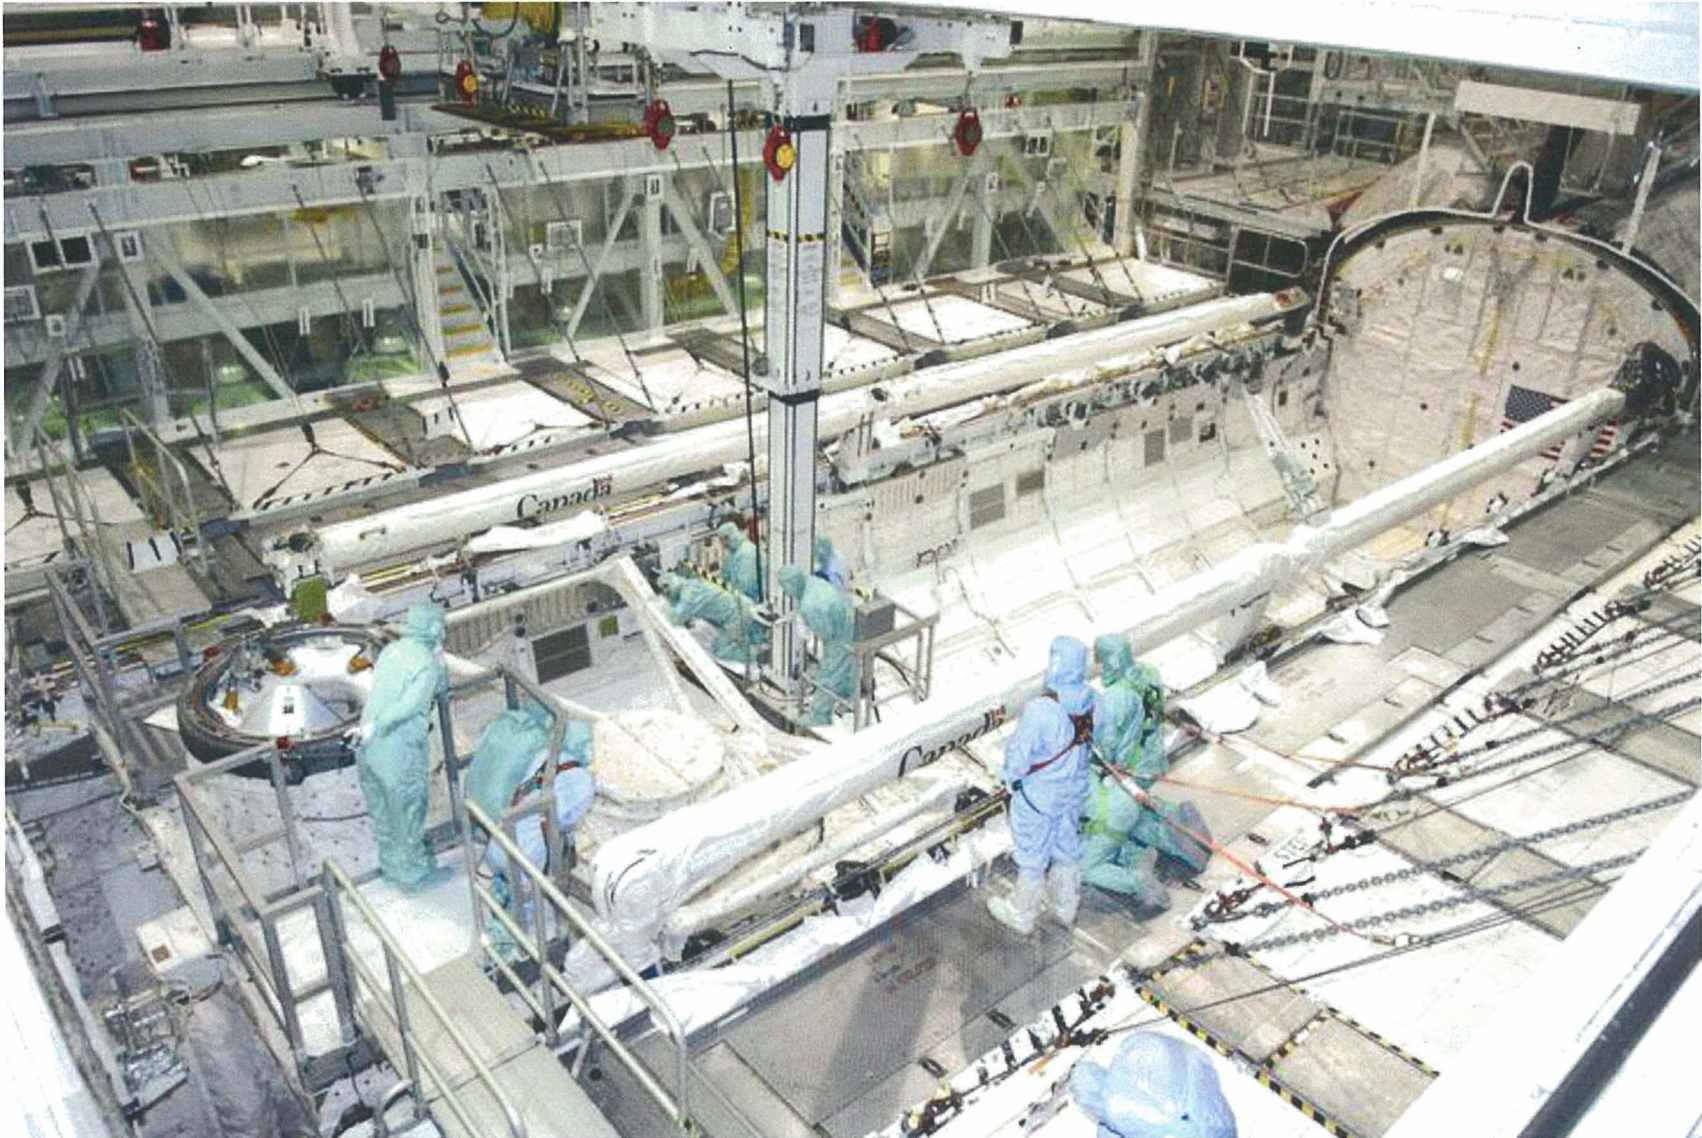
OPF Payload Bucket Hoist

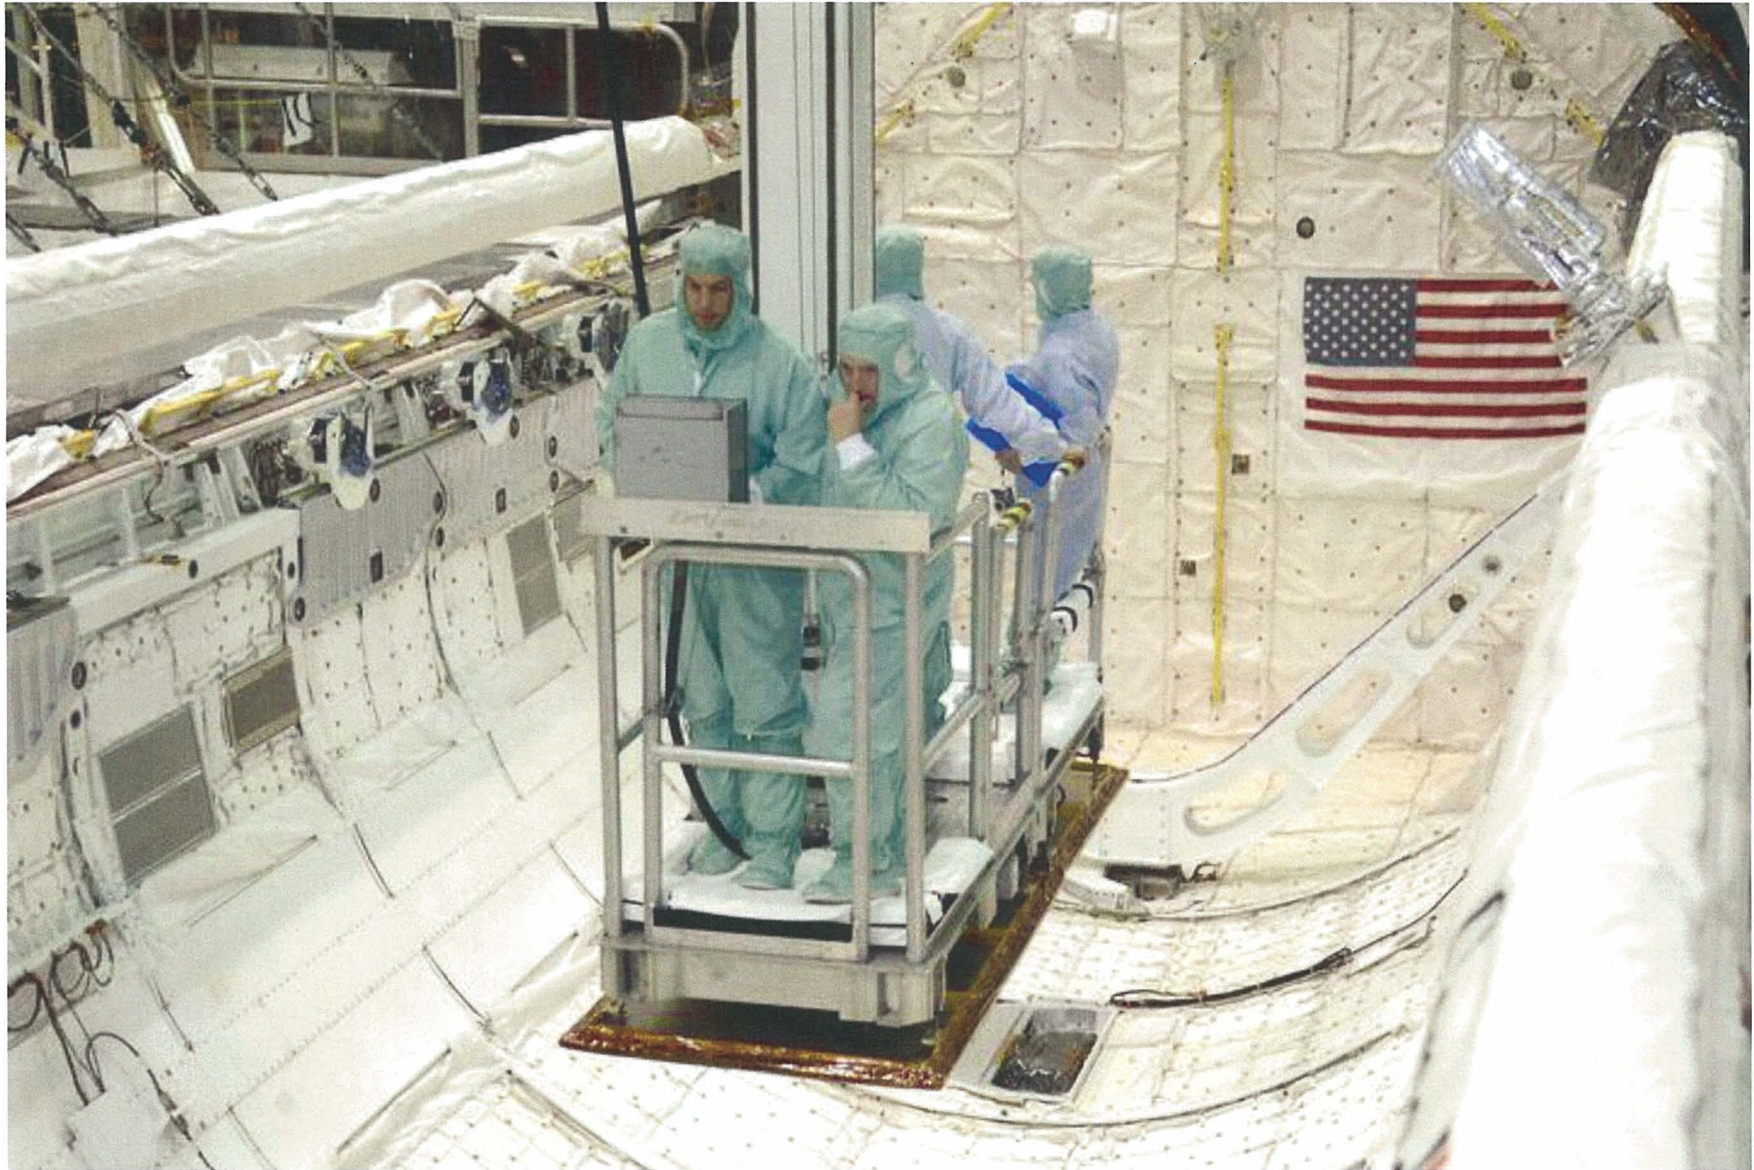
OPF Payload Bucket Hoist

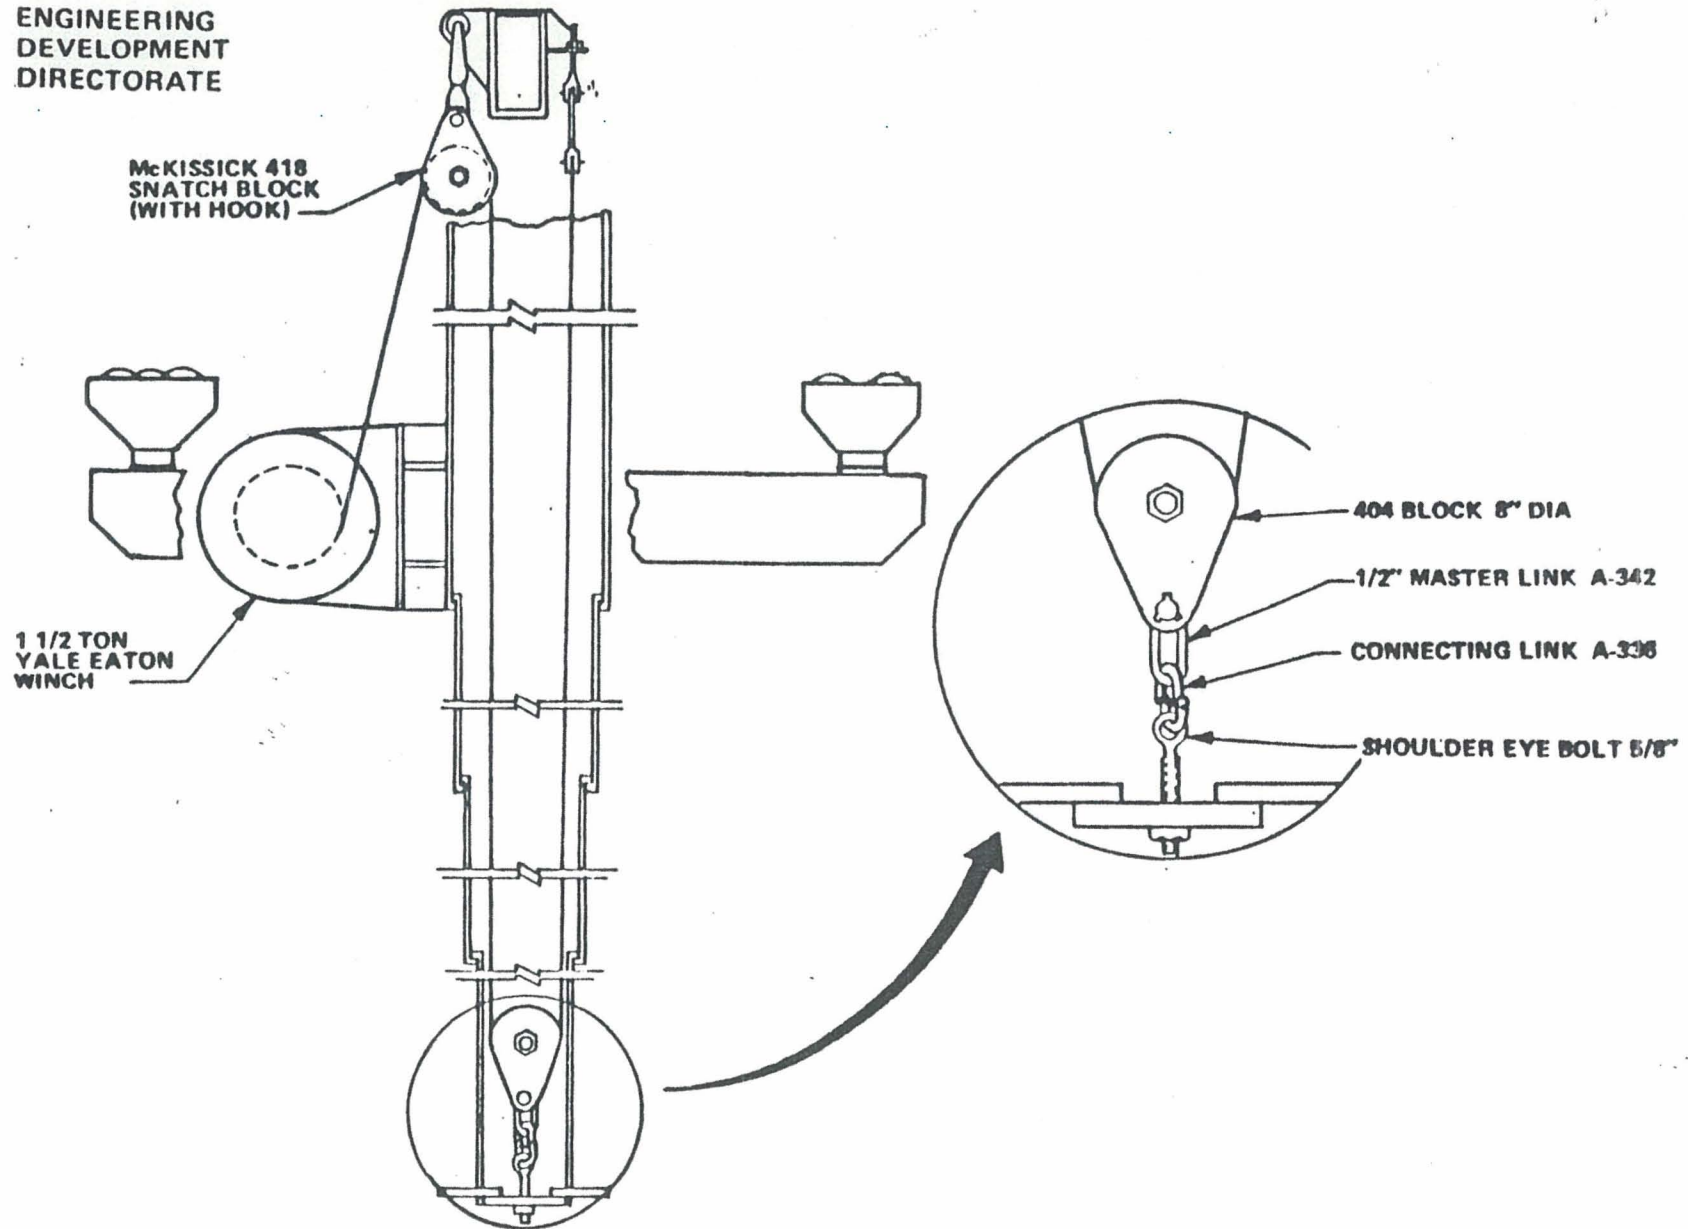
Figure 9-B-2. Side view of Access Platform hoist, cable system, and telescoping tubes

- While placing the platform in the full up position to stow the bucket hoist the operators were using the upper limit switch as a control stop (only one control type upper limit switch).
- The location of the limit switch set point and the mechanical configuration of telescoping tube assemblies was so close that there was little room for drift between the limit switch actuation point / hoist stop point and mechanical contact between the telescoping tube assemblies and hard structure. All 8 Payload Bucket Hoists were adjusted the same way.

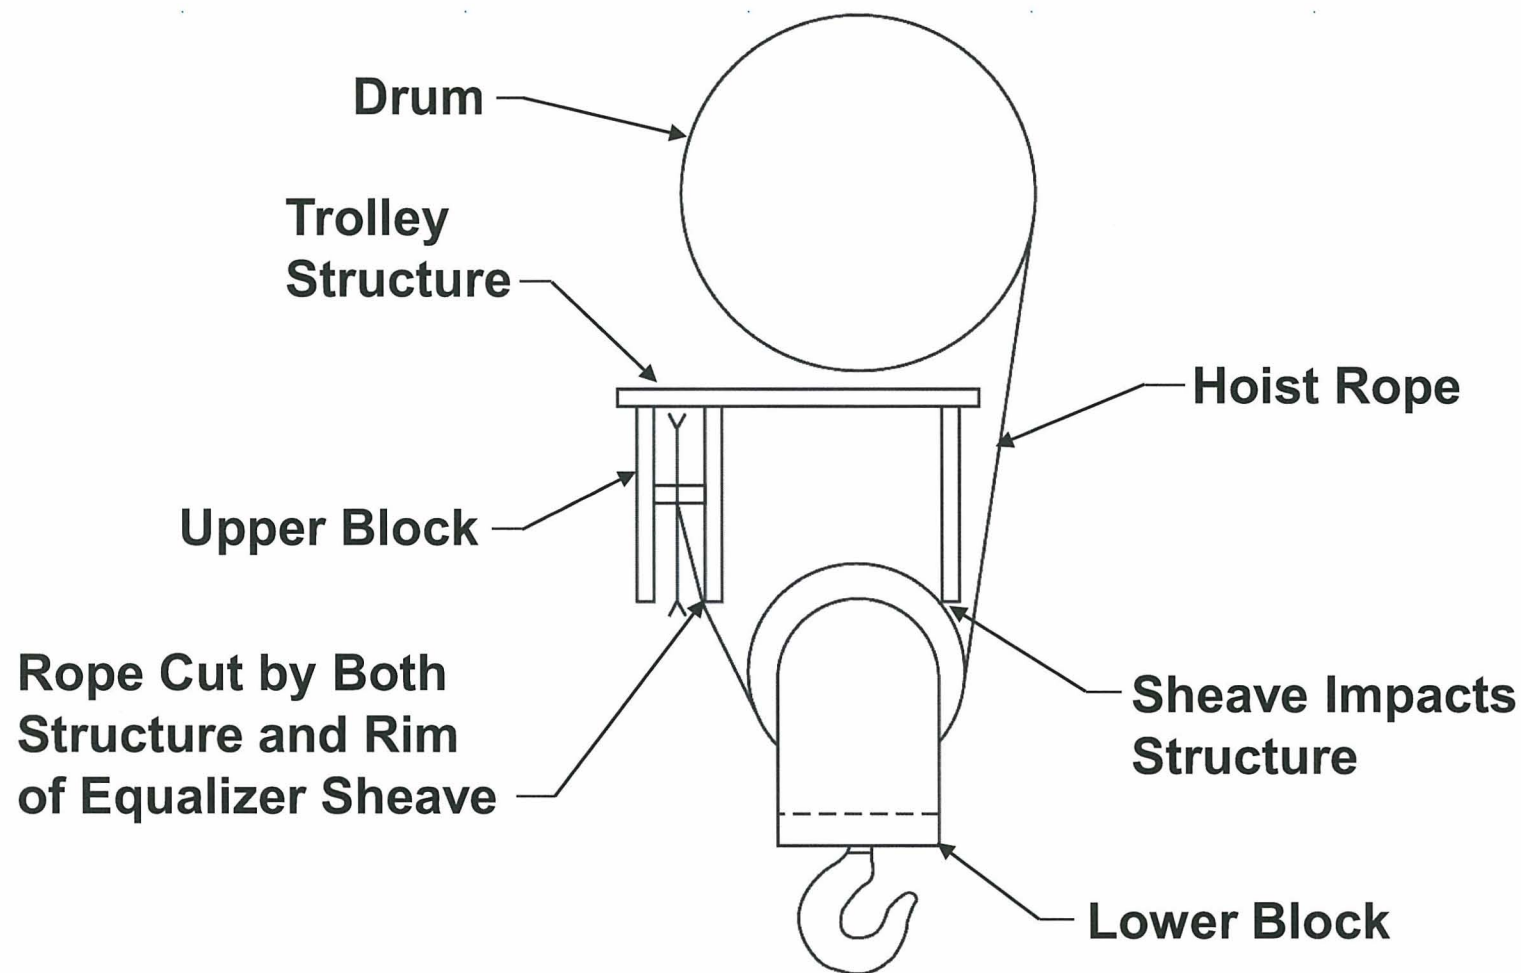
- Two-Blocking
 - Two-blocking is the result of hoisting beyond the intended safe upper limit of hook travel to the point of solid contact between the load block and the upper block or hoist/trolley structure. The usual result is immediate failure of the wire rope, due to the ropes being cut by the grooves of the drum or sheaves.

Two-Blocking

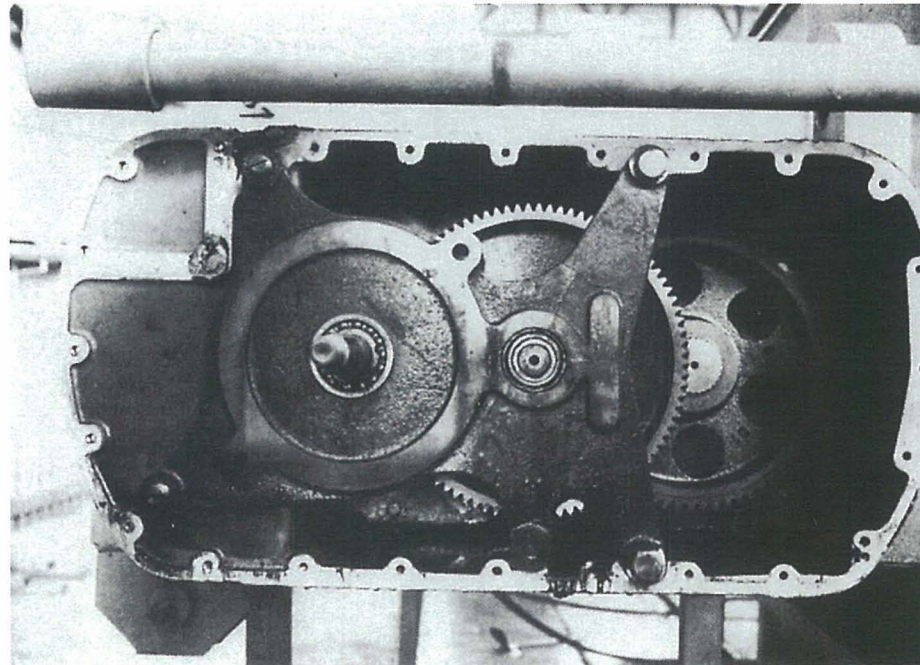
Gear Box Depicting the Spider Plate and Relative Position of the Spider in the Gear Box

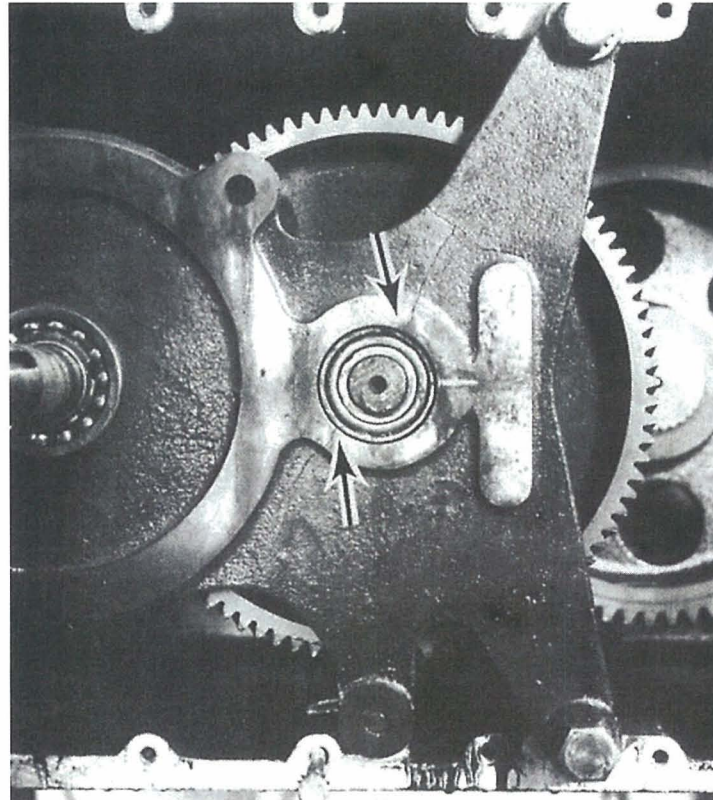
Cracks Around the Shaft and Bearing

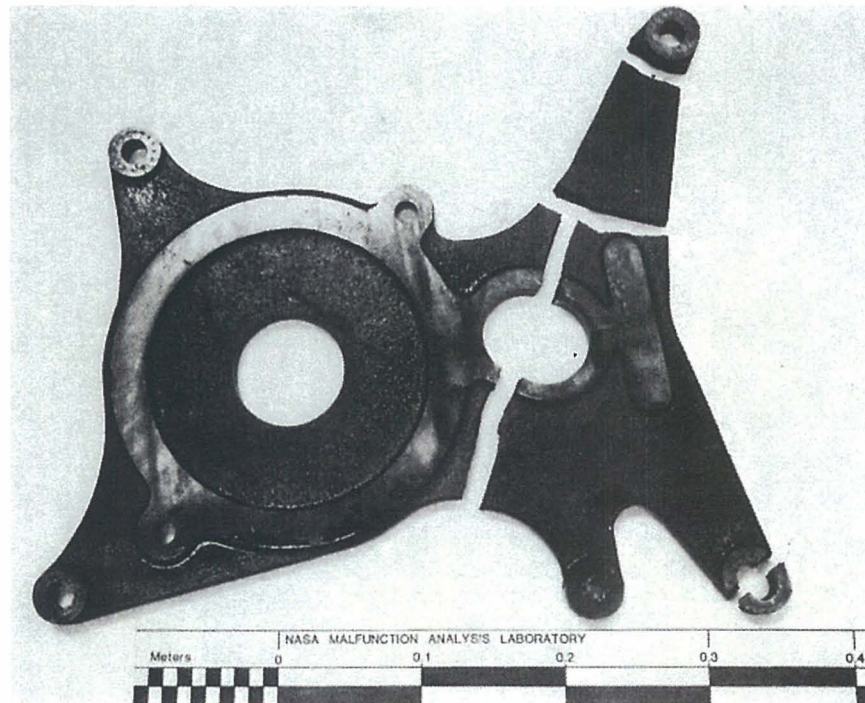
Spider Plate Removed From the Gear Box

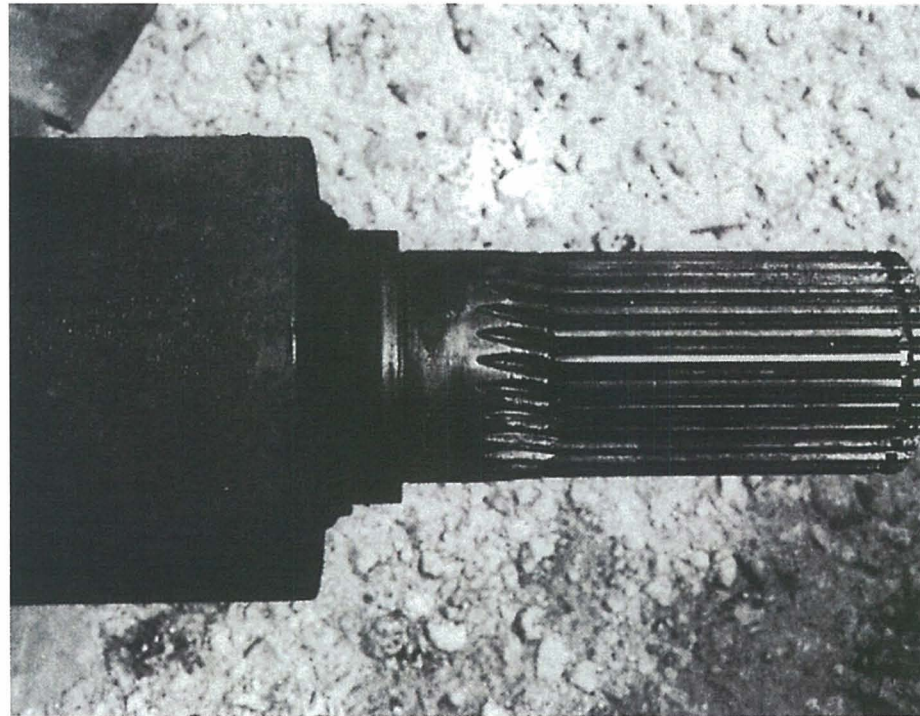
**Drum Shaft Spline Depicting the Deformation Found
After the Spider Failure**

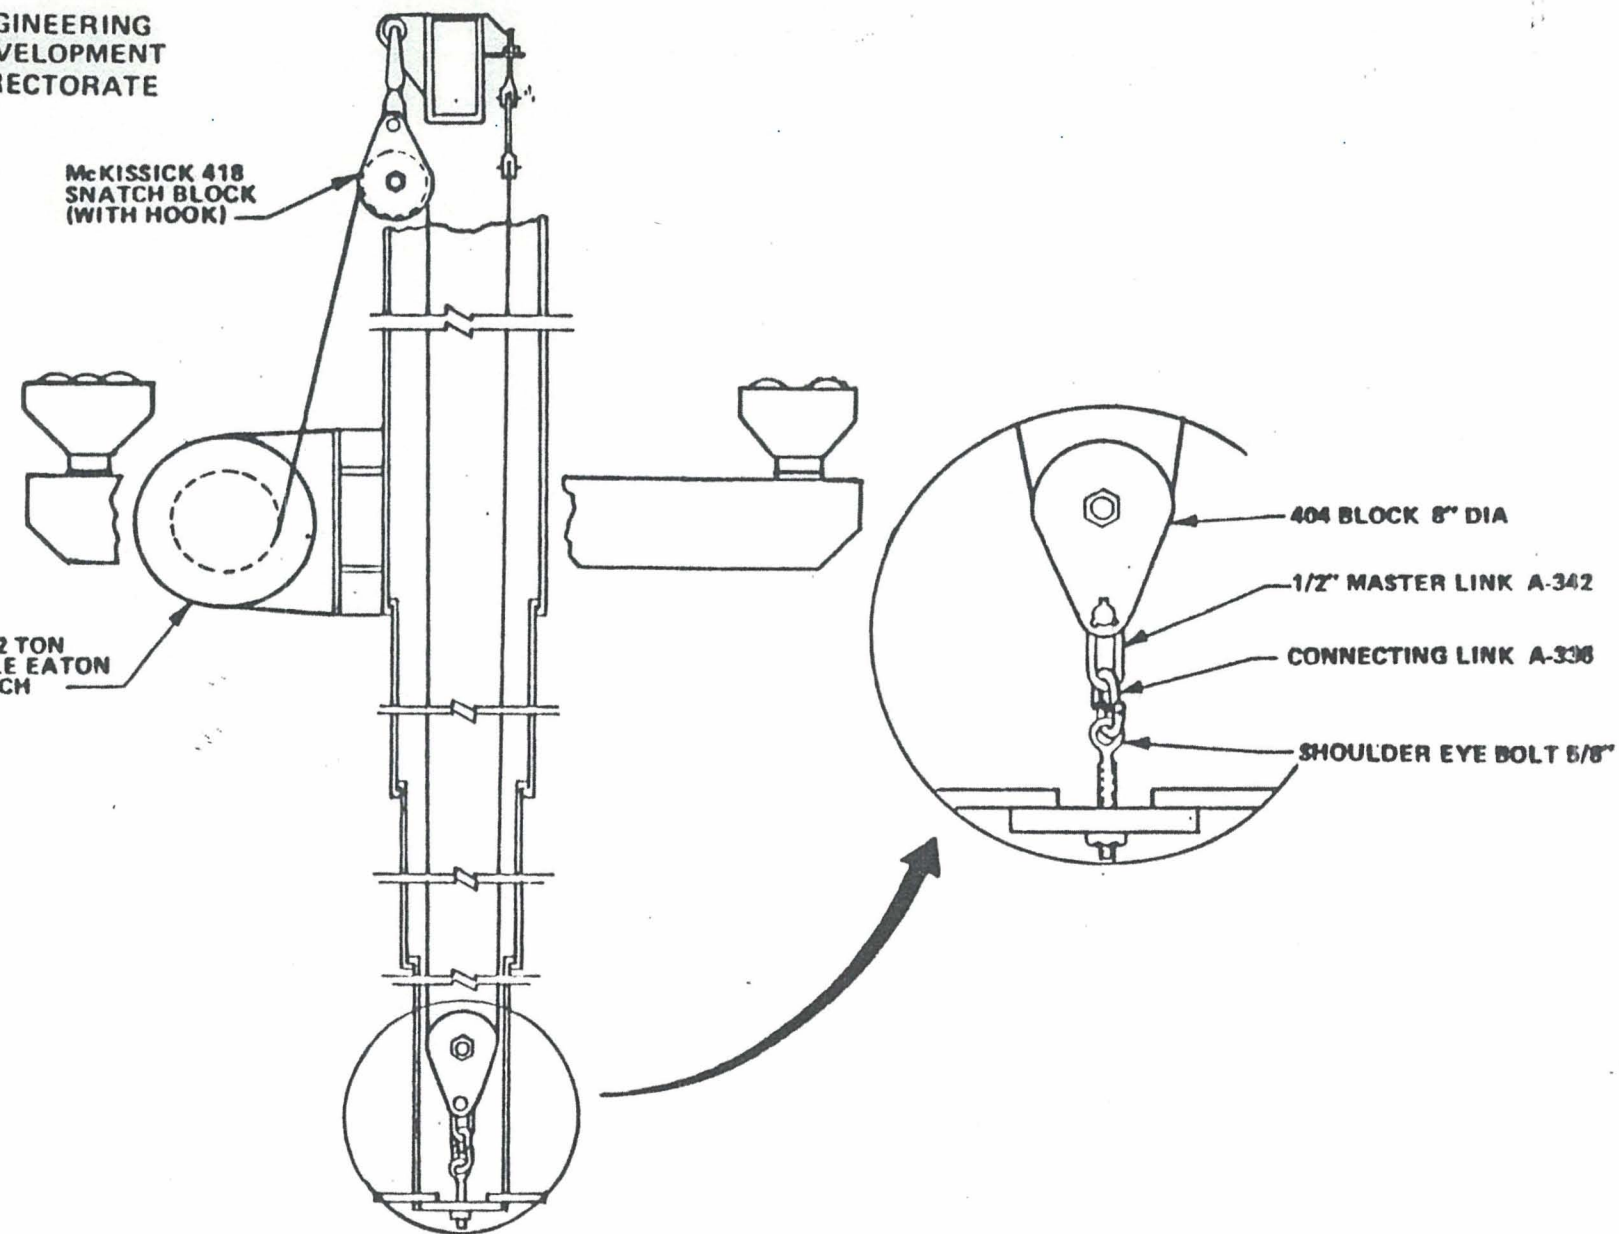
McKISSICK 418
SNATCH BLOCK
(WITH HOOK)

1 1/2 TON
YALE EATON
WINCH

404 BLOCK 8" DIA

1/2" MASTER LINK A-342

CONNECTING LINK A-336

SHOULDER EYE BOLT 5/8"

Figure 9-B-2. Side view of Access Platform hoist, cable system, and telescoping tubes

- The operators were “just barely” too blocking the hoist every time they stowed the bucket.
 - Before the accident... inspection of the 10 inch telescoping tubes revealed evidence of metal to metal contact on the supporting structure. Apparently no action was taken by the inspectors.
 - Before the accident... The actuator arm on the hoist limit switch broke. The Bucket Hoist was Locked Out / Tagged Out until repairs could be made.
 - The operators were confused about the type of Lock Out / Tag Out imposed on the equipment and they operated the unit anyway.

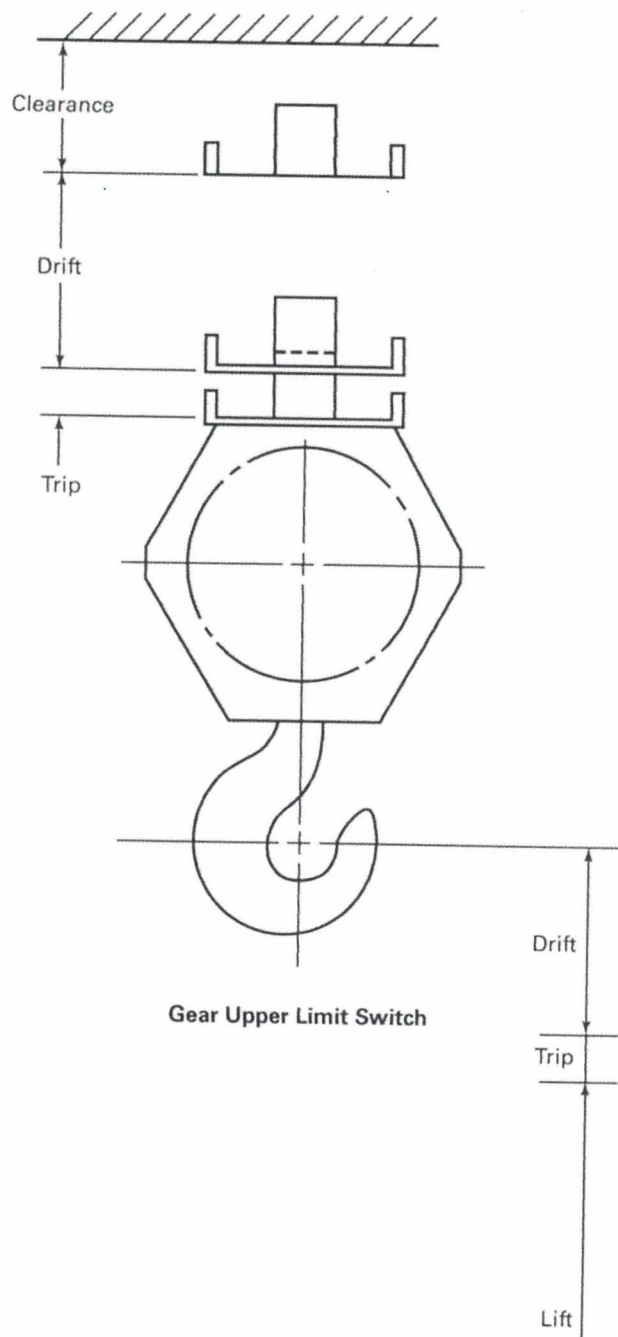
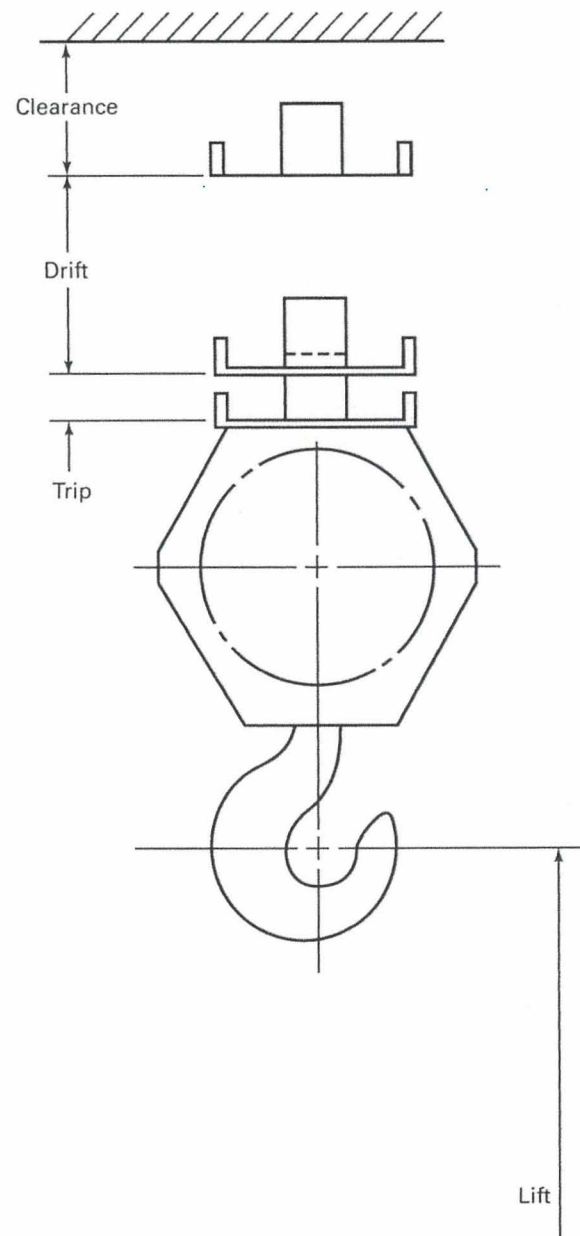
- Note in the figure... Each limit switch needs adequate space between their set points
 - They must have a distance to trip the switch
 - They must have adequate distance to allow for drift
 - And finally they must have adequate clearance between the each switch.
- Adequate space is necessary between the two switches and between the final switch and two blocking.
